# Chichi, Taiwan Earthquake of September 21, 1999 (M7.6)

## AN EQE BRIEFING

## GENERAL OVERVIEW

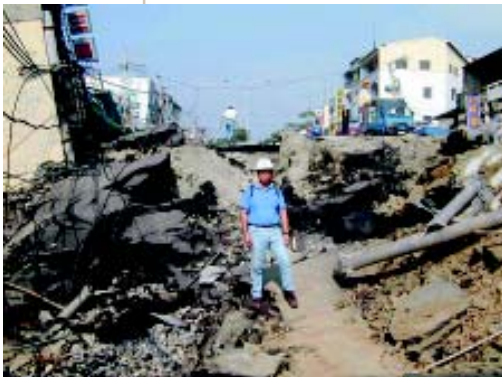
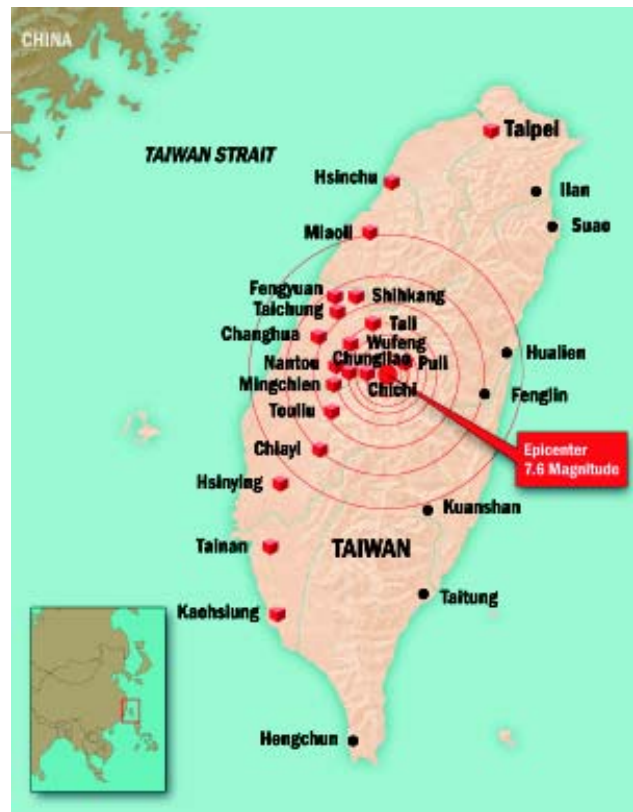
This was the largest earthquake to hit Taiwan in recent history. High ground accelerations on the order of 0.5g to 1.0g were recorded in the epicentral region. Significant ground failures of various types were observed. One of the most spectacular aspects of this event was the extreme amount of vertical ground offset observed along the fault rupture. Offsets measured 3m to 6m in many regions. At the dam in Shihkang, nearly 15m of vertical offset was noted, disrupting water supply to Taichung.

*Shihkang dam failure caused by vertical fault rupture of 15m through the dam (right photo). Vertical fault rupture across the main street of Fengyuan (bottom photo).*

The drinking water reservoir in Shihkang was lost due to failure of the dam. The left side of the dam dropped about 15m due to ground faulting. The tremendous force of the earthquake distorted the entire massive structure (all gates are inoperable) and caused one section to fail. The dam will likely not be repaired. Reportedly, a new dam will be constructed upstream.

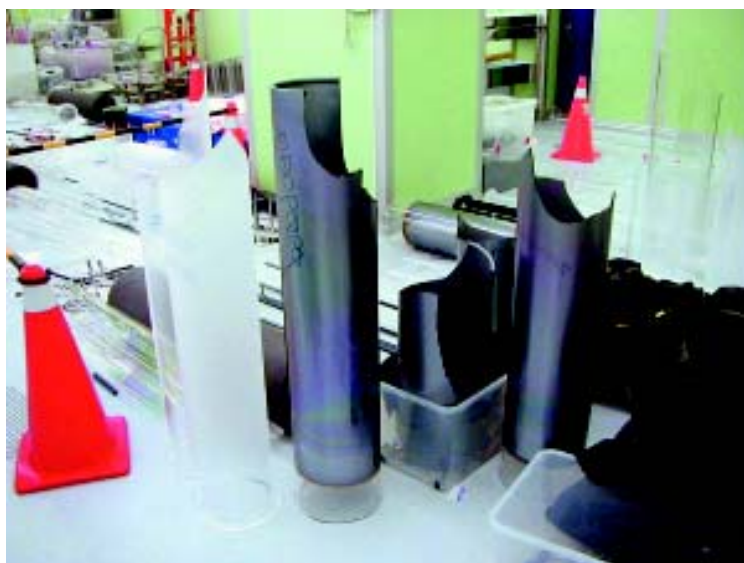
*Widespread damage to quartz tubes in wafer fabs demonstrates vulnerability of wafer processing equipment to earthquakes (left photo).*

Varying equipment damage was reported in the Science Park manufacturing facilities. The worst reported damage entailed breakage of quartz tubes inside vertical diffusion furnaces. Most of the wafers contained in the quartz "boats" were also cracked when they were tossed during the shaking. There were many cases of process equipment shifting, and at least one case where a tall cabinet overturned. Fortunately, there was no report of fire or toxic gas release due to the damaged tubing. Had

Despite the known seismic risk, much of the very expensive process equipment in these facilities is not designed with adequate seismic protection. Damage to this equipment can contribute greatly to business interruption, because replacement of critical tools could take several months.

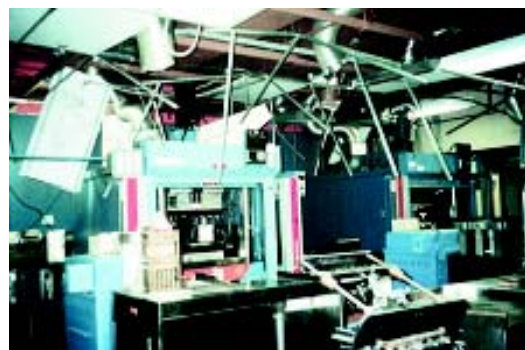
*Damage to typical high-tech facilities in the 1990 Philippine earthquake (bottom photo).*

the shaking been even slightly stronger, damage and loss would have been much more extensive. Such damage to typical high-tech facilities occurred in the 1990 Philippine earthquake.

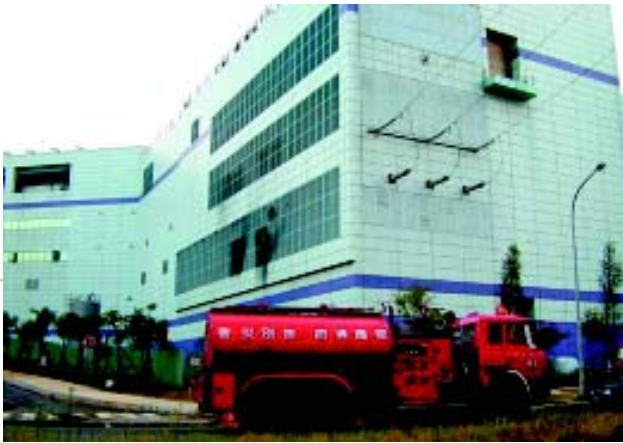
*Fire damage due to a standby generator failure in the Hsinchu Science Park.*

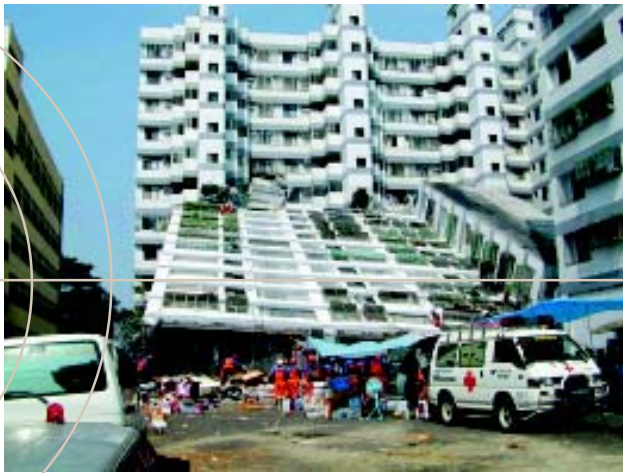
*Collapsed 12-story condominium in Tali.*

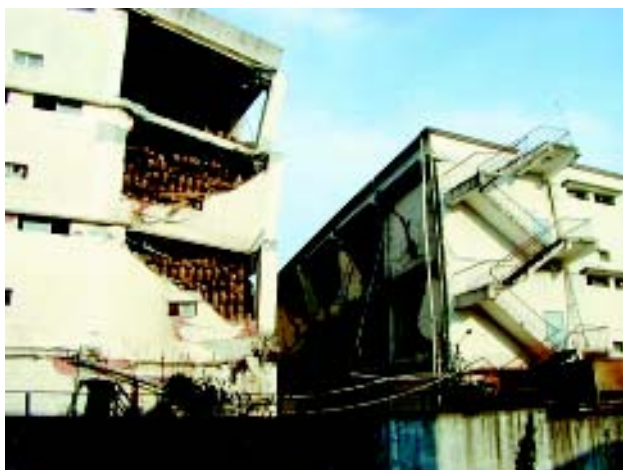
*Damage to rice wine aging buildings at the Puli winery.*

In the city of Puli, a 30-year-old winery sustained heavy damage. Many of the buildings were constructed of reinforced concrete frames with masonry infill walls, and many collapsed. A brewery in the city of Nantou experienced losses from a fire resulting from spilled spirits ignited by sparks. Business interruption costs are projected to be very high.

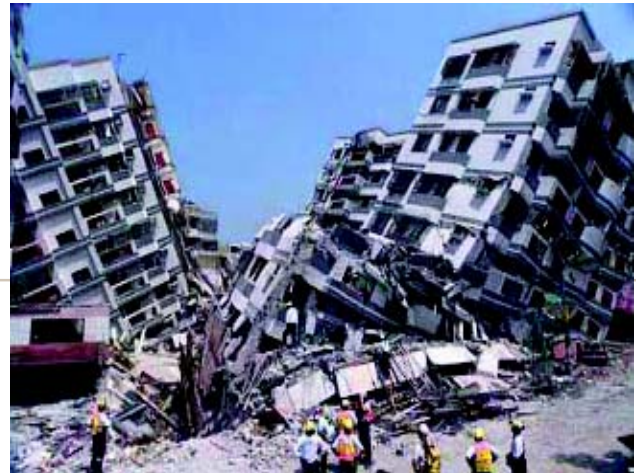
*Collapsed condominium complex in Touliau.*

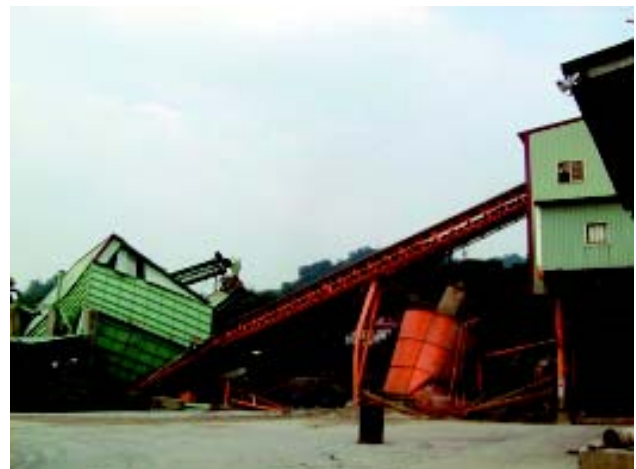
about 40 km of the fault line, damage was observed at essentially every aggregate and concrete batch plant. The seismic design practice that is used for the design and construction of such facilities clearly requires a major revision.

*Typical collapse of aggregate and concrete batch plants, which is one of many in the epicentral area.*

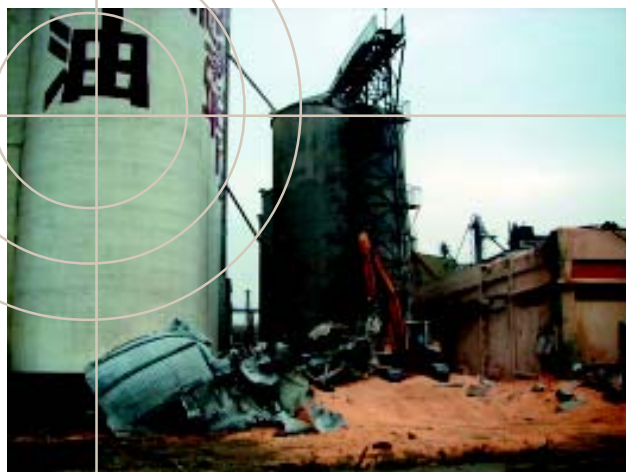
At Taichung Port, about 70 km from the epicenter, many large flat-bottom steel storage tanks containing molasses were affected by the earthquake. Sloshing of the contents caused heavy damage to the roof and walls of the tanks, resulting in content spillage. A nearby food processing plant had several grain silos, which were filled with product by plant operators because of an impending typhoon predicted before the earthquake. When the earthquake hit, all of the full silos collapsed.

*Collapsed grain silos located in Taichung.*

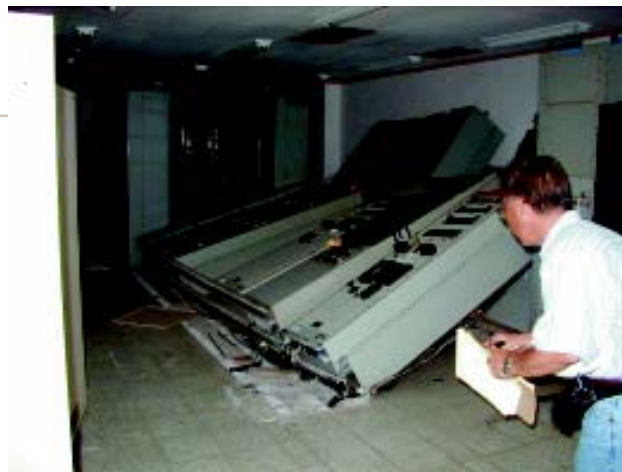
*Topped control equipment in 345 kV Chungliiao substation.*

The 345 kV Chungliiao substation is the most important facility within the national electrical power distribution system. It is the link for the surplus power generated in the south to be transmitted to the north. Only minor structural damage was noted in the main control building. Although the control panels in the control building were not damaged, some protected panels overturned due to anchorage failure. Equipment components out in the yard sustained heavy damage. This was due to the intense ground shaking as well as some local soil settlement and slumping. As many as 200 components, including ceramic insulator columns, bushings, and buses, will need to be replaced.

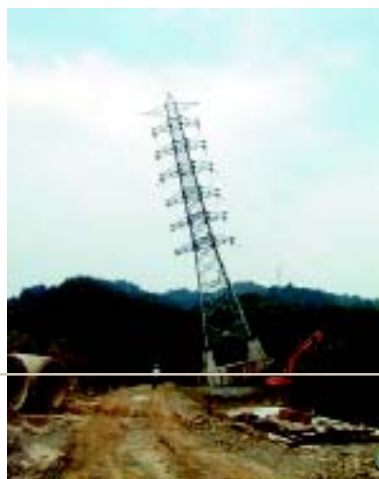
*Foundation failure of a transmission tower due to fault rupture in Mingchien.*
