# Chichi, Taiwan Earthquake of September 21, 1999 (M7.6)

## AN EQE BRIEFING

## GENERAL OVERVIEW

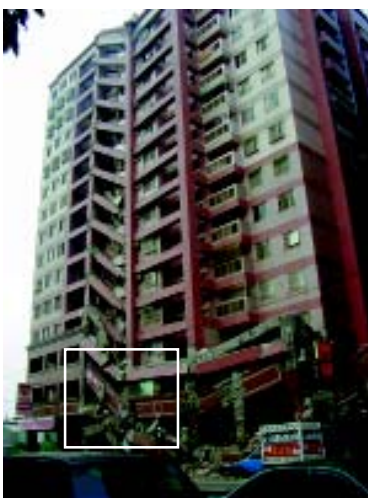
*Collapsed 14-story condominium in Taichung attributed to faulty design or construction.*

More than about 5 km from the fault line, it was repeatedly observed that the older buildings performed well, but many of the modern structures over six stories tall performed poorly. This can be attributed to faulty design and construction, and improper enforcement of seismic design provisions in the building code - even though the building code used in Taiwan is comparable to those used in Japan and in California.
